*"Recording
the Biodiversity
and Habitats of
Lough Allen"*

Ref. No: LL14b/34/EQ

Large Static Foam area in still water of Inishfail.

08-09-2014

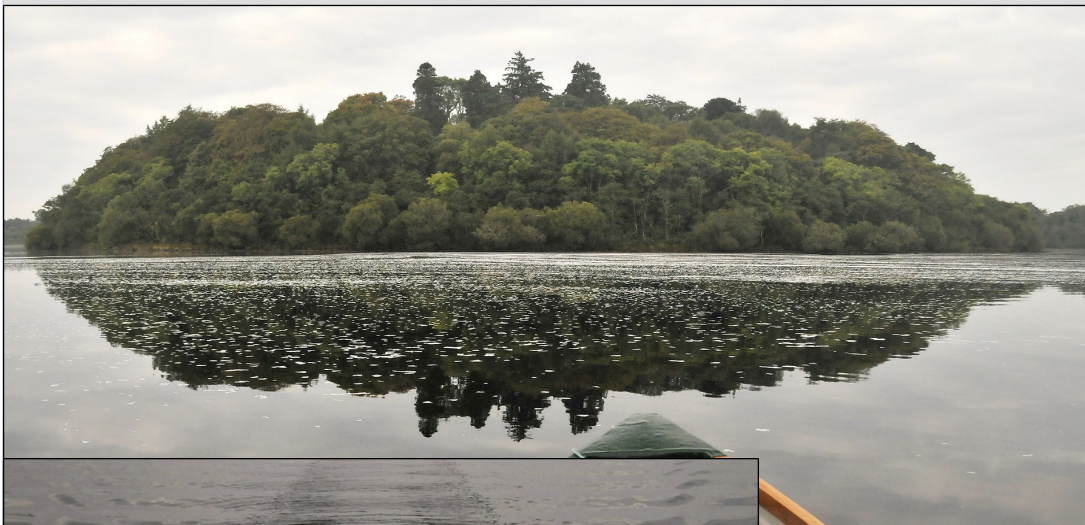
Observations: Initially this day promised fair with only very slight persistent bubbling behind our boat as we left Cormongan. So slight and so ephemeral as to be almost classified as normal in a lake changing from oligotrophic to mesotrophic? However, within a short while clearly visible widespread contamination became obvious. This is the scene that met us as we approached Inishfail heading south.

There was a large becalmed area of dense floating foam. As you can see the area in question is flat calm with only a trace of a northerly breeze elsewhere on the lake at this time. Agitation of surface water was producing persistent foam; agitation of sub-surface water (e.g. by the propeller) was not! We suspect that this is an artificial surfactant material emanating from further up the lake, travelling down the Shannon channel and surfacing off the Cormongan Islands and then being concentrated by whatever breeze there was in the shallow area at the tip of Cormongan. This was most unsightly — its impact on wildlife may be minimal at this stage; its effect on tourism, in an otherwise pristine lake, questionable.

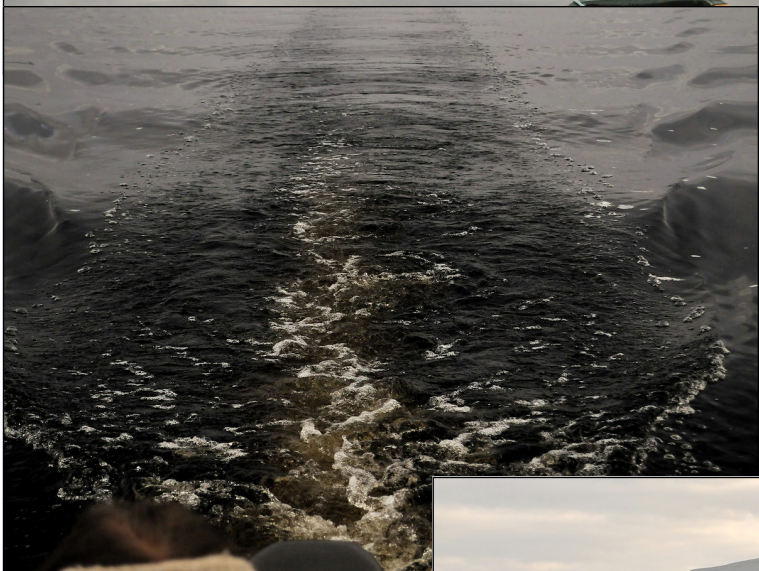
LEFT: This is a **Standard Boat Test** conducted as we approached the area shown above. Going by the large leaden bubbles at the sides of the wake, we would classify this as 'severe' contamination. Persistent bubbles have been a frequent feature in many parts of the lake this Summer (when the conditions have been calm enough) but are rarely this large or this persistent.

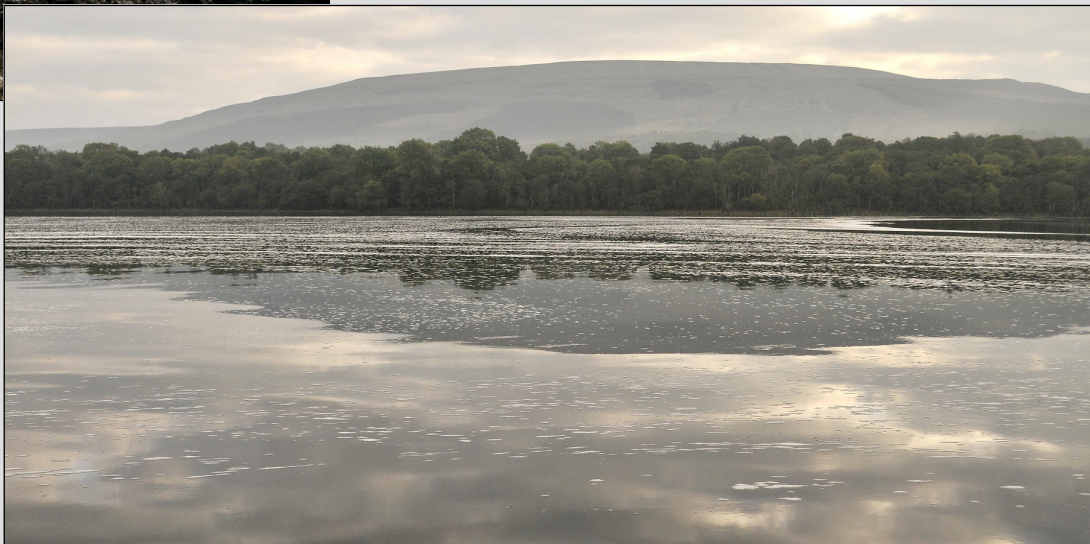
BELOW: This is a view from close to Inishfail looking across the channel to Slieve an Iarann. It shows the widespread nature of the scum and also where it clears as water flows into the channel and towards the sluices. (This image may be enlarged.)
